TECHNICAL REPORT NO. 12104

TESTING OF A DEMOUNTABLE TIRE
ROADWHEEL CONCEPT

U.S. ARMY TANK AUTOMOTIVE COMMAND Warren, Michigan

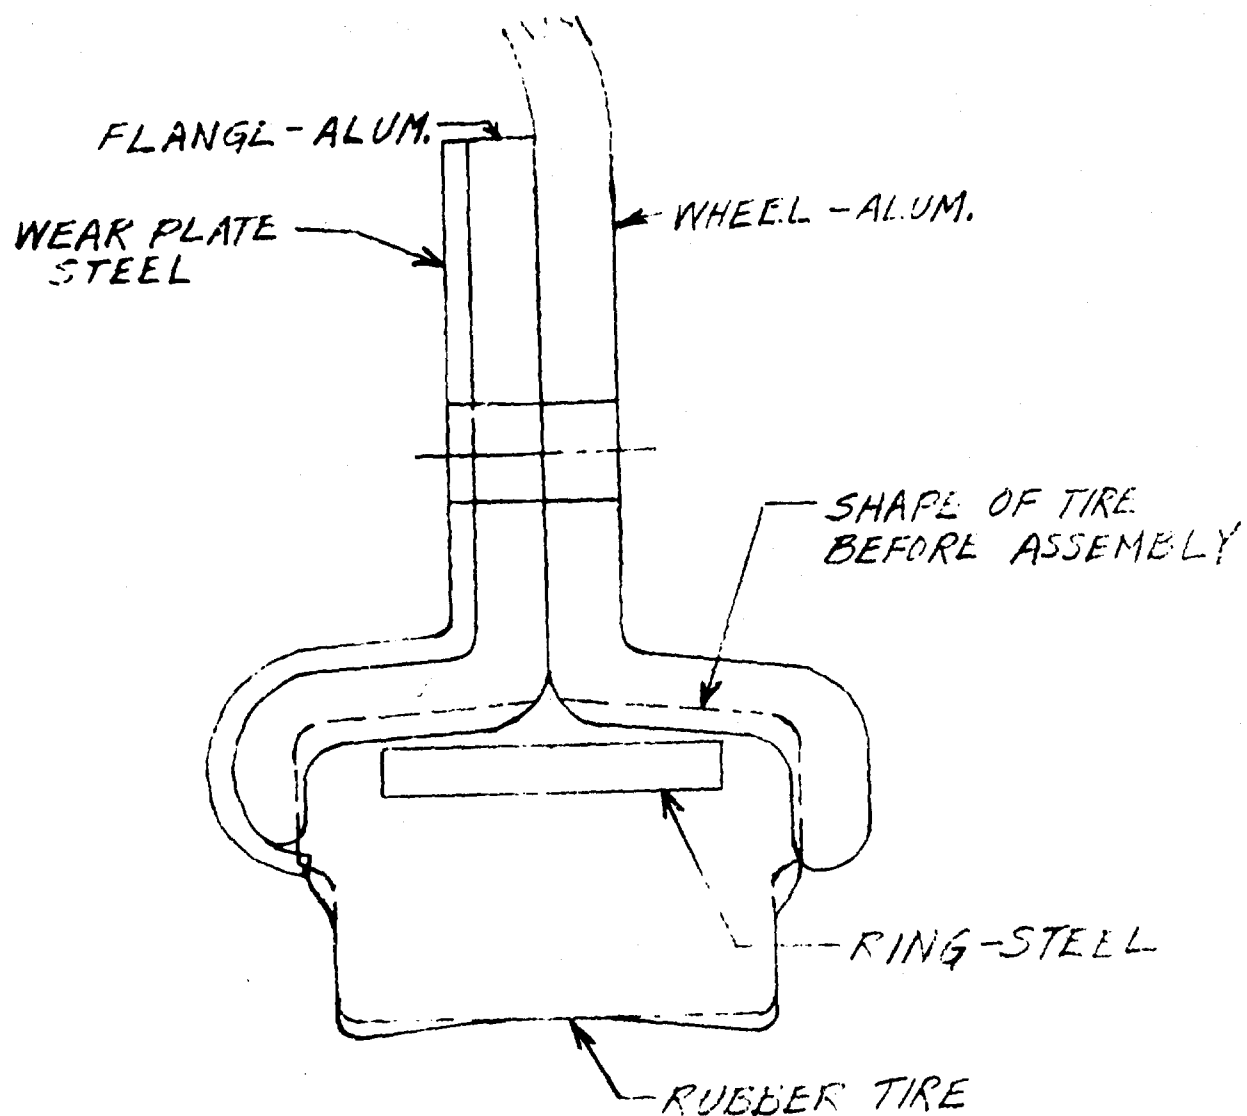
FIG. 1

CONSTRUCTION OF WHEEL. NOTE HOW RUBBER IS SQUEEZED FROM BETWEEN WHEEL AND RING DURING CLAMPING. OUTER EDGES OF TIRE ARE RAISED AS RESULT.

The wheel is formed of 3/8" thick aluminum. The rim is sloped at 5° and has an edge raised about 5/8". There is a matching flange which permits the tire to be assembled and clamped. There is a steel ring embedded in the rubber tire. While the flange is being tightened to the wheel, the excess of rubber between the wheel and the ring is compressed and forced to flow around the edge of the ring. This causes the tire to bulge upward at the edges as shown in Figure 1 and in Figure 2. The components are shown in Figure 3. The assembled wheel is shown in Figure 4, and in figure 5.

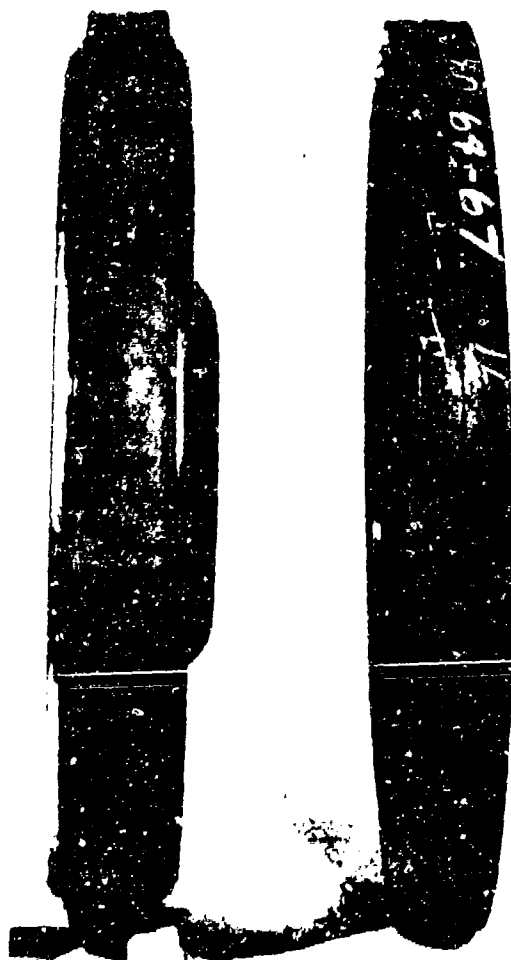
FIGURE 2 - Assembled wheel on the left and unassembled tire on the right.
Note the raised edges of the tire on the assembled wheel.

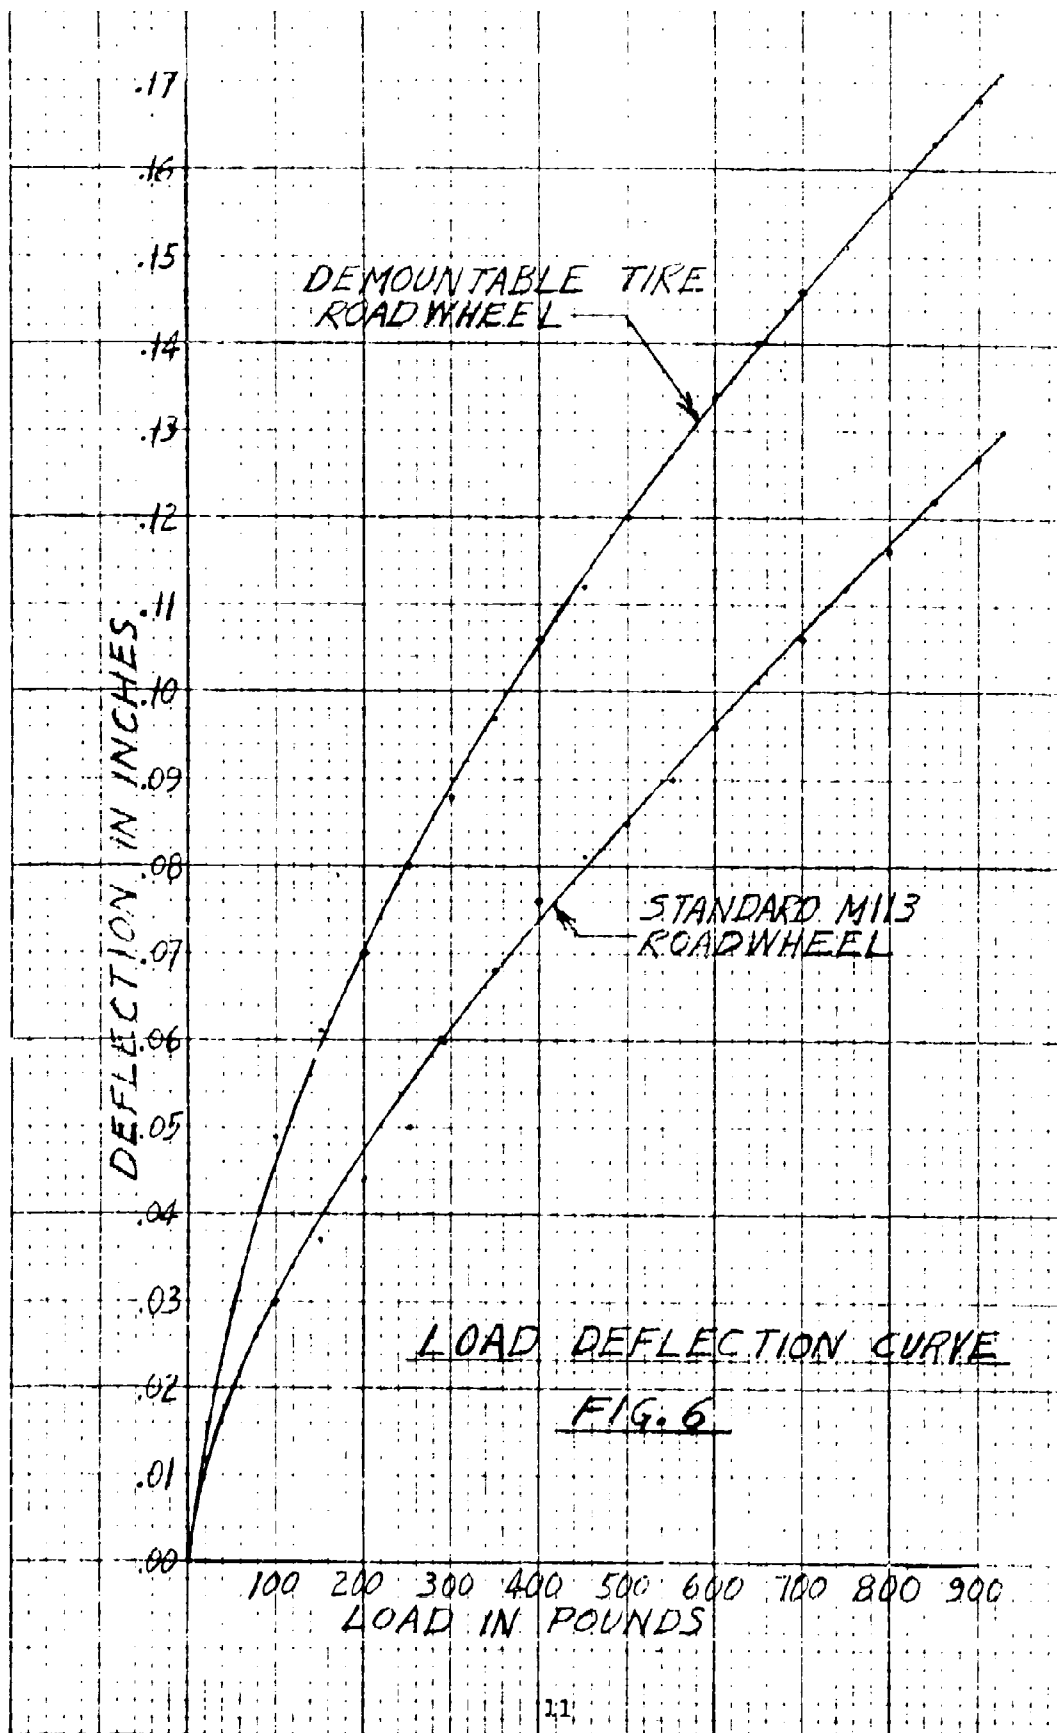
Note that the weight of this wheel is approximately 25 pounds more than the 35 pound weight of the standard M113 roadwheel. Also the durometer specification for the standard M113 wheel is 70+5 making the rubber on these test wheels somewhat softer. It should be noted that the standard specification for roadwheels in MIL-T-3100B is 70+10. A load-deflection curve is shown in Figure 6.
